SB/AC/116 HOME
G/7 EXPORT
MAY 1965

Self Switching Wiper Motors - Interchangeability

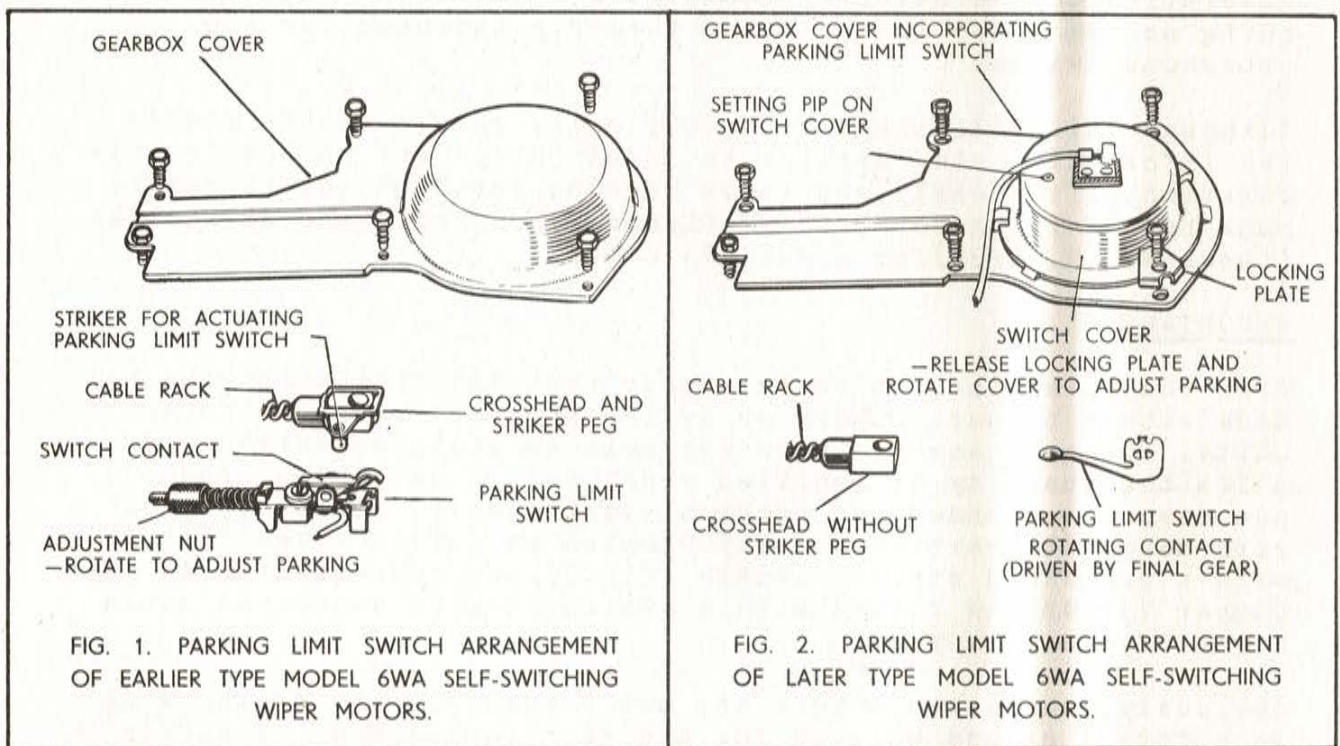
Two methods of achieving self switching have been employed with 6WA motors. In each case the necessary components - which are entirely different - are illustrated in fig. 1 and fig. 2.

The earlier type (see fig.1) incorporates a parking limit switch that is actuated by a striker peg located on the crosshead of the cable rack assembly.

Later production of these motors have a limit switch housed under the domed cover of the gearbox. This switch (see fig.2) comprises a fixed contact and a rotating contact driven by the final gear. Unlike the crosshead striker type, the cable racks for these motors are not fitted with a striker peg.

Because of the difference between the cable rack assemblies the earlier type of motor (requiring a striker located on the cross-head) cannot be used as a replacement for the later version. Attempts to do this (without changing rack assembly) will result in failure of the motor to park correctly.

The rotating contact version, however, can be used as a replacement for the crosshead switch type without any alteration to the existing cable rack - the unwanted striker being accommodated in the space formerly intended for the crosshead switch.

Obviously, these two motors are not completely interchangeable as suffix A cannot be used for a direct replacement of suffix B. In service faulty motors marked 75509B must be replaced with part number 75584 and not 75509A.
