SB/GN/90 HOME

May 1968

MODIFIED FIELD TERMINAL ASSEMBLY FOR LUCARIZED GENERATORS

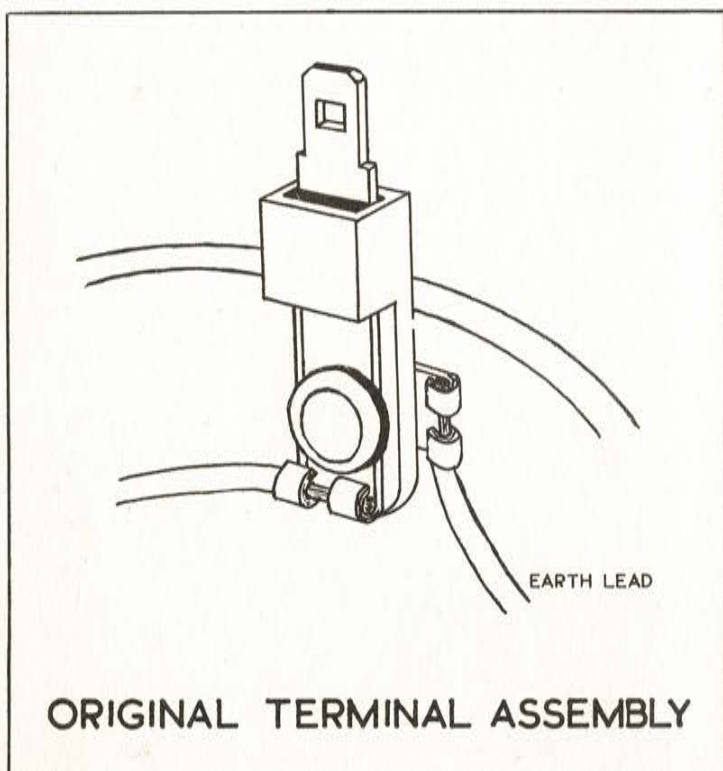
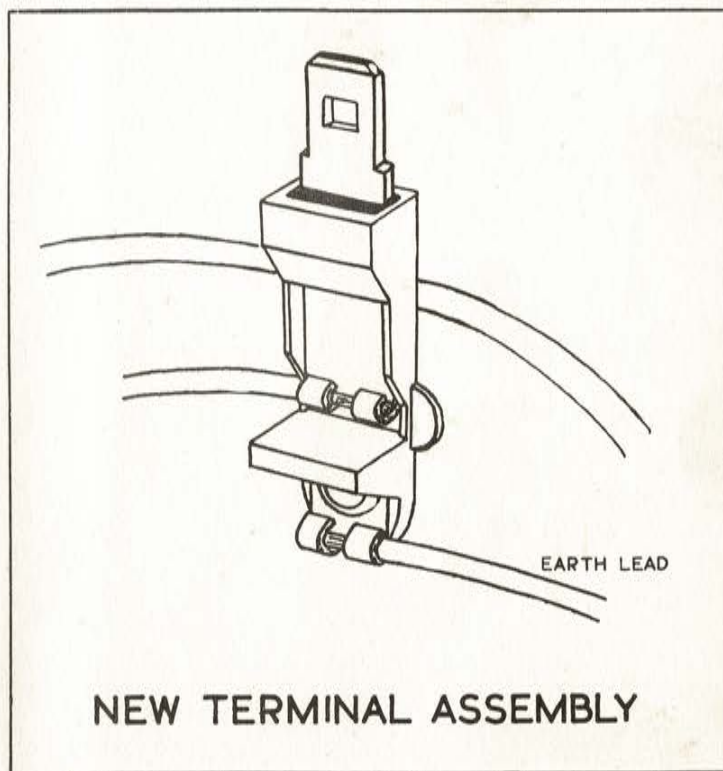
The field terminal assembly as fitted to Lucarized C40, C42 and C45 generators has recently been modified to eliminate the risk of the field terminal shorting to the yoke.

The part number of the modified terminal assembly is 54216878 and it will replace terminal assemblies 54211890 and 5421064.

To replace the original terminal assembly with the modified one, it may be necessary to lengthen the field coil leads. This can be done by carefully cutting the tape covering the coil until sufficient lead is exposed, and then retaping as necessary.
