SERVICE INFORMATION

Vol. 1 No. 10

LAND-ROVER PETROL AND DIESEL MODELS

December, 1972

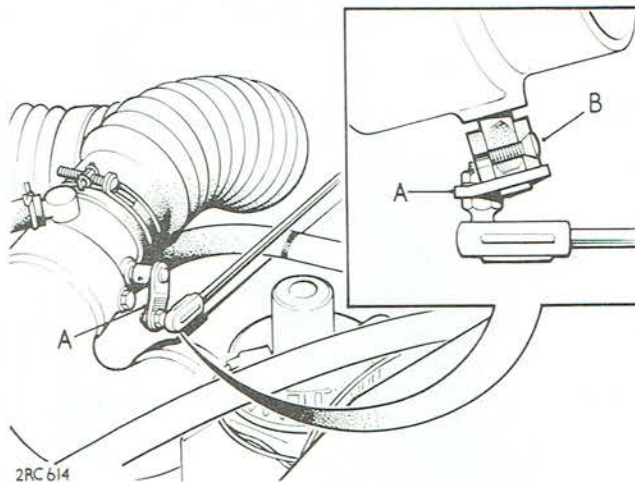
Fig. 1 Inlet manifold butterfly valve

A small number of cases have been reported where the clamp screw, which locks the operating lever to the butterfly valve, has come loose.

If this condition is present on a vehicle, it can cause either a loss of vacuum or excessive smoke to be emitted from the exhaust. Should Distributor or Dealer personnel come across this problem they are advised to first check the positioning and tightness of the clamp screw. If the component is found to be loose it is recommended 'Studlock' or 'Loctite' is applied and the screw re-tightened.

A—Operating lever
B—Clamping screw

Production Department, as an interim measure, from April, 1972, have been applying 'Studlock' on the screw. To overcome this possible condition permanently, however, it is anticipated that a re-design of the particular area concerned will be carried out.

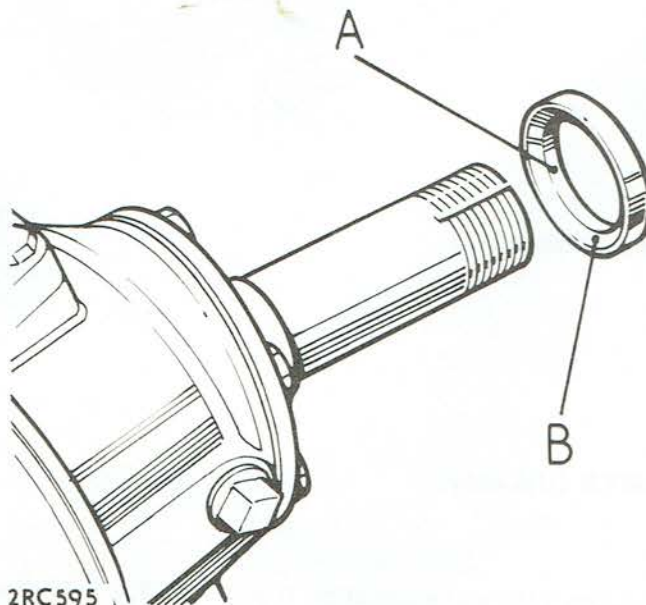
Fig. 2 Distance piece for inner hub bearing

A number of Land-Rover owners have experienced hub oil leaks which, in most cases, may be attributed to the sintered iron type inner bearing distance piece, Part No. 217351. This may be subject to splitting in service and cases of porosity have been reported, believed to be due to surface cracking.

A—Apply Bostik 772 to inner circumference
 B—Apply Bostik 772 to tapered surface

Where hub oil leaks are due to this condition the inner bearing distance piece can be removed as described in the appropriate manual operation listed above and replaced with the latest mild steel type, Part No. 599698, ensuring that Bostick 772 is applied liberally to the inner circumference and the tapered surface which faces the back plate.

NOTE: Because of the material change the mild steel distance piece cannot be removed in the same way as the sintered iron type. In this case, it is recommended that, by exercising reasonable care the distance piece can be partially cut through with a sharp chisel to loosen it, when it can be gently prised off.

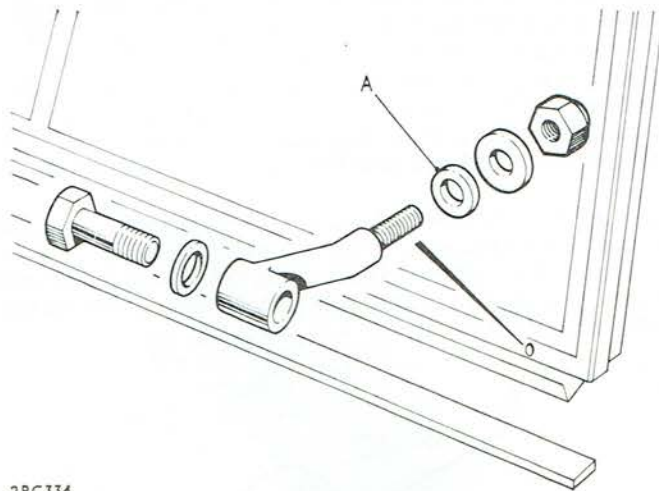
Fig. 3 Windscreen pivot arm fixings

REMARKS: In certain instances the fibre washer between the windscreen and the pivot arm cracks after initial tightening and during service this washer is displaced by vibration, thereby allowing movement between the windscreen assembly and the windscreen pivot arm. The eventual consequences of this condition is a cracked or broken windscreen pivot arm. The fibre washer has now been replaced by a copper washer and this should be used for all replacements.

A—Copper washer
