Item 78

REMOVAL OF SALISBURY DIFFERENTIAL UNIT

109 in. Land-Rover Series III.

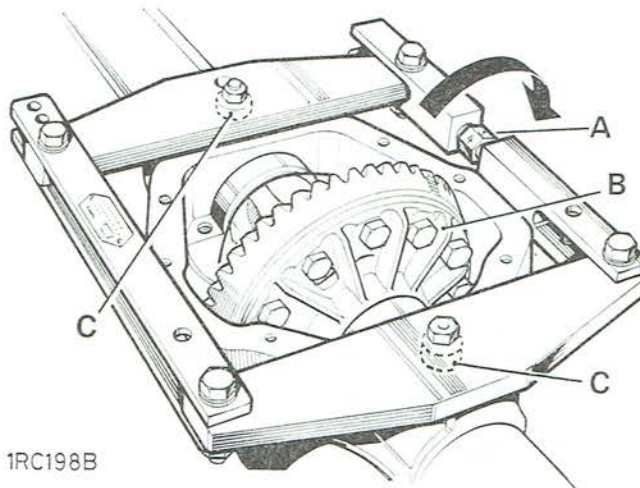
1RC198B
Fig. 1 Axle spreader tool 18G131C

To correct the adjustment procedure of the turnbuckle on the axle spreader tool 18G131C in French and German versions of the Land-Rover Repair Operation Manual.

The '**CAUTION**' note in the workshop procedure concerning the adjustment of the turnbuckle on the axle spreader tool 18G131C in the French and German versions of the Repair Operation Manual is based on an earlier English version. This should be corrected to conform to the current details in the Repair Operation Manual, English, Part No. 607314, Operation 51-15-01 sheet 2 as follows:

CAUTION. To prevent permanent damage to the gear carrier case it must not be over-stretched. Each flat on the turnbuckle is numbered to enable a check to be made on the amount turned. The **maximum stretch permitted** is 0,30 mm (0.012 in.), equivalent to **three flats**.

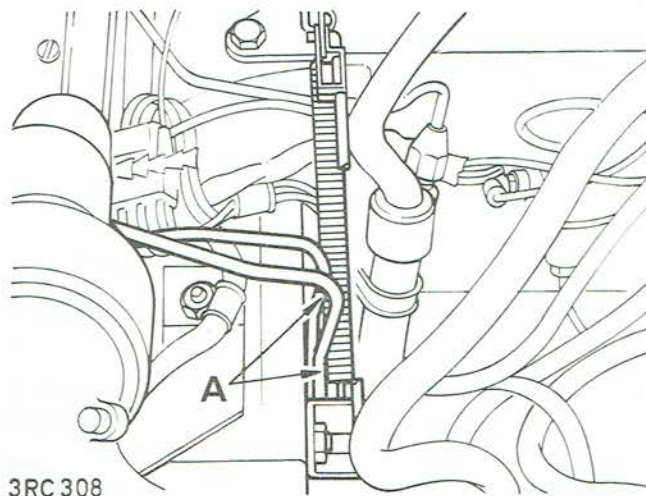
Fig. 2 Clearance between brake pipes and accelerator return spring

Item 80**SUBJECT: BRAKING SYSTEM****MODELS:** Land-Rover Series III, RH STG equipped with dual braking system.**OBJECTIVE:** To ensure dual brake pipes do not foul the accelerator control rod return spring.**REMARKS:** A limited number of the above vehicles have been produced with a minimal clearance between the accelerator control rod return spring and the dual brake pipes leading from the tandem brake reservoir to the five-way branch union situated on the right hand side of the chassis.

It is possible that in certain instances of vehicle operation or servicing the clearance between the accelerator spring and the brake pipes may be reduced, leading to a chafe condition. You are therefore requested to check for this condition on vehicles which pass through your workshops at the normal service intervals and, if necessary, reposition the pipes to create adequate clearance.

A — Check for clearance at these points

The condition has now been rectified on current vehicles.
