SERVICE INFORMATION

Vol. 1 No. 21

LAND-ROVER PETROL AND DIESEL MODELS

November, 1973

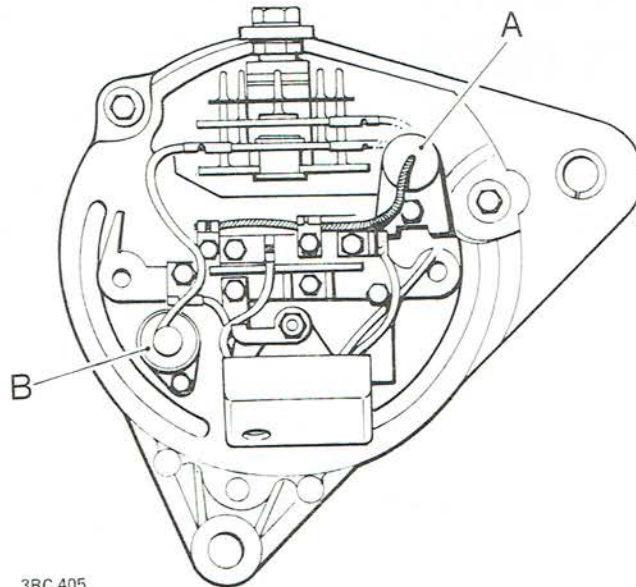
3RC 405

REMARKS: A surge protection diode has been incorporated in the current range of Lucas ACR alternators. The diode is connected between the 'IND', terminal and earth, which protects the regulator and/or alternator diodes from high voltage surges due to poor external wiring connections or battery lead removal when the engine is running.

Fig. 1. Location of surge protection device

A—Surge protection device

B—Suppressor

The above surge protection device can be fitted to earlier ACR alternators. However, it may be necessary to re-locate the suppressor to the position shown.
