The Rover Company Limited, Solihull,
Warwickshire, England

June, 1972

INDEX

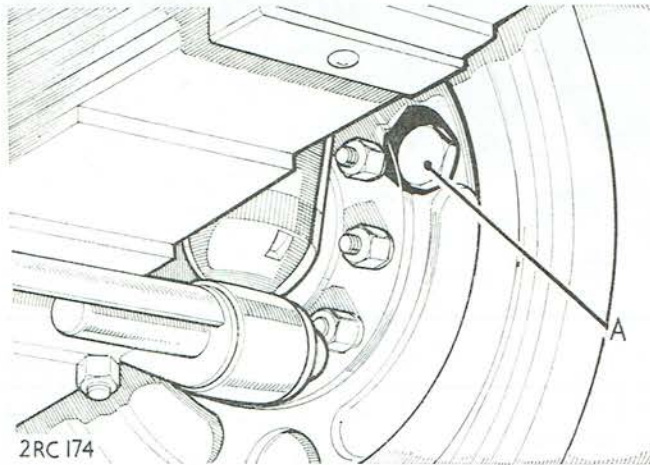
REMARKS: If low brake pedal is a problem in Service it has been found that an improvement can invariably be made by carrying out the simple adjustment procedure to the **rear brakes** as detailed below.

This operation centralizes the brake shoes to the drum without putting any excessive strain on the snail adjusters which could result in damage.

Fig. 1 Wheel brake adjustment

1. Raise the rear of the vehicle and place on stands.
2. Ensure the rear wheels turn freely.
3. With the foot brake firmly applied adjust **one** snail cam to its maximum position.
4. With the foot brake released, undo the cam one or two notches until the wheel just turns freely.
5. Repeat operations 3 and 4 on the remaining rear brake shoe snail adjuster.
6. Check the brakes for correct operation.
7. Lower the vehicle to the ground.

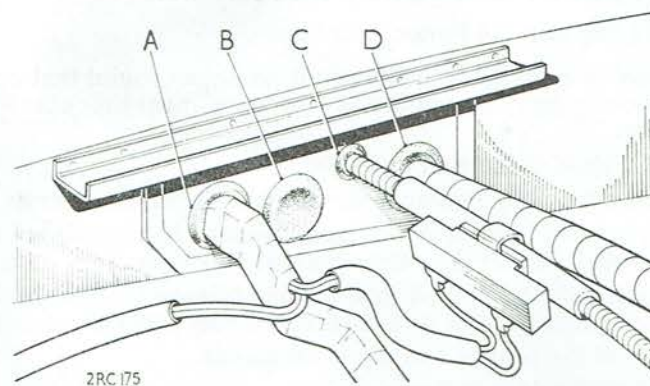
Some early Series III vehicles have the speedometer cable routed through the grommet hole which is normally blanked off. This incorrect assembly forces the cable through a sharp angle and can promote early speedometer inner cable failure.

Fig. 2 Correct location of speedometer cable RH Stg. models

Service Personnel should familiarise themselves with the correct layout as illustrated and give particular attention to this point when early Series III Land Rovers are inspected.
