SERVICE INFORMATION

Vol. 1 No. 8

LAND-ROVER PETROL AND DIESEL MODELS

October, 1972

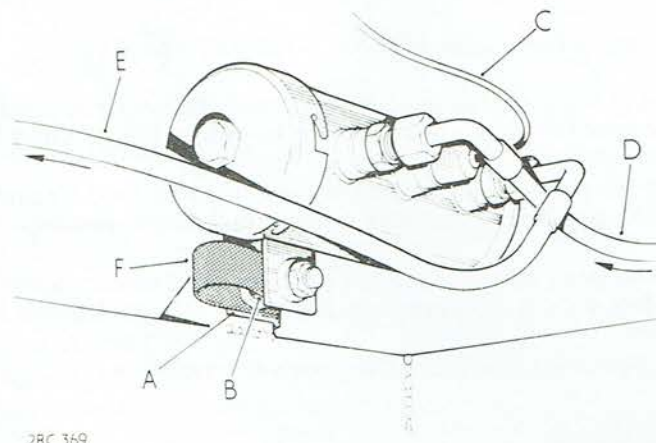
Fig. 1 Fuel pump installation

MODIFICATION: Introduction of Bendix electric fuel pump, replacing the S U fuel pump previously used, to overcome problems of corrosion.

The Bendix fuel pump is being fitted to current Land-Rover 109 vehicles with 2.6 litre engine.

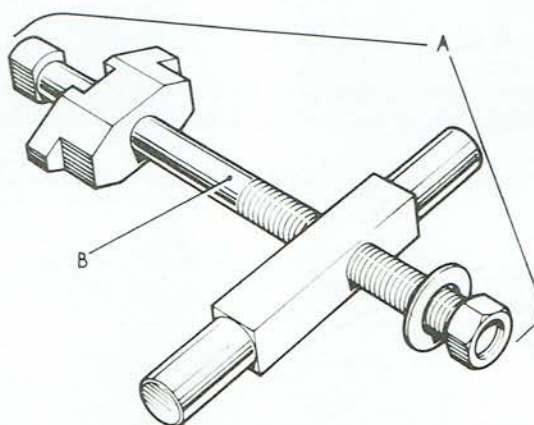
Fig. 2 Removal tool for pinion head bearing

On all Series III models and at the vehicle suffix letter change from 'G' to 'H' on Series IIA models, the pinion oil seal retainer is integral with the differential casing and not removable as previously; therefore a longer centre bolt has been provided for the Service tool used to remove and refit the pinion head bearing cup, to cater for the extra depth of casing involved.

B—If required centre bolt only obtainable separately under Part Number 262757A detail 3

Lengthening the centre bolt has resulted in a tool number change from 262757 (which remains suitable for early models) to 262757A which is suitable for both early and late models. The longer centre bolt is available separately under Part No. 262757A detail 3 to enable holders to modify their original tool Part No. 262757 which is then suitable for both early and late models.

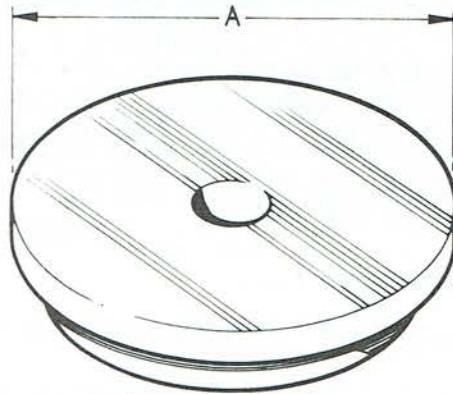
Fig. 3 Press block for pinion head bearing

A—Early tool Part No. 262758 measures 69 mm (2.7 in.).
Later tool Part No. 262757-1 measures 77 mm (3.0 in.)

In conjunction with the above modification, the opportunity has been taken to provide a new press block which gives a greater contact area with the pinion bearing cup. The new press block Part No. 262757-1 replaces the earlier press block Part No. 262758 for the following models:

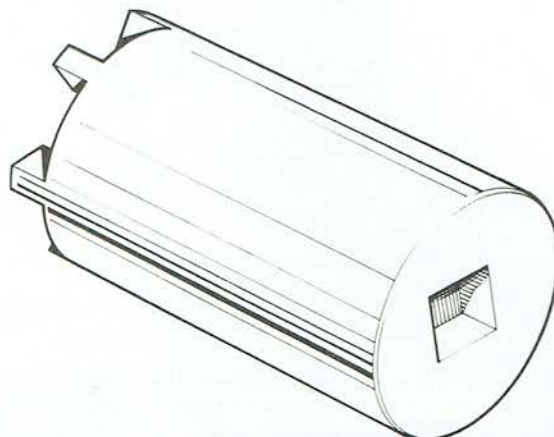
Fig. 4 Spanner for stub shaft nut

MODIFICATION: Introduction of a Service tool for removing/refitting the circular castle nut which retains the front hub driving member and the axle stub shaft.

REMARKS: The above Service tool is designed to engage in the castellations of the circular castle nut. The free end is provided with a 12.7 mm (0.500 in.) square hole to accept a suitable wrench.
