The Rover Company Limited, Solihull,
Warwickshire, England

August, 1972

SUBJECT: MAIN HARNESS, REPOSITIONING

MODEL: Land-Rover Series III 2¼ litre Petrol

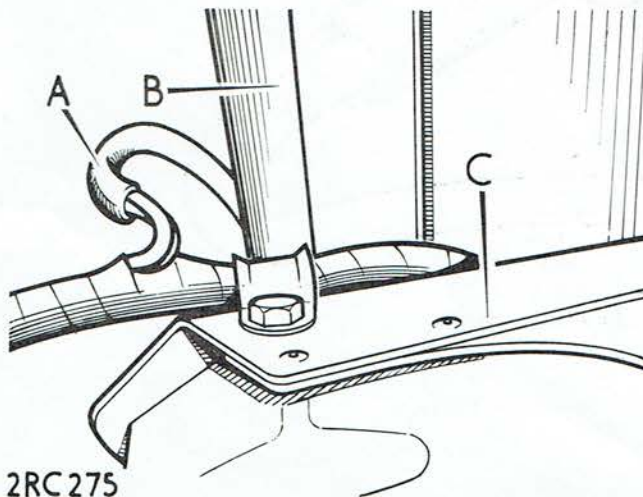
Fig. 1 Correct location of solenoid feed wire

- A—Solenoid feed wire
- B—Air cleaner
- C—Wing valance

It has been brought to our attention that in certain instances a 'foul' condition may be present between the air cleaner, main harness assembly and the right hand side wing valance.

Service personnel are requested to examine all earlier vehicles, during routine maintenance checks and, if required, peel back the non-adhesive harness binding tape, thus allowing the solenoid feed wire to be re-routed away from the obstruction.

Should the solenoid feed wire be badly chafed, it should be replaced with the modified main harness assembly.

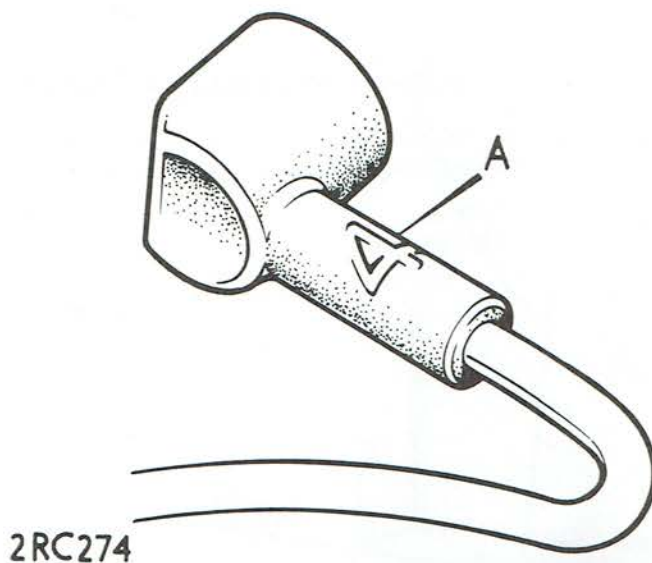
Several cases of engine misfire, and poor starting under wet or damp conditions have been reported and investigation has shown this to be caused by poor moulding of the right angled coil boot on the coil to distributor high tension ignition lead.

Fig. 2 Identification of ignition lead

A—Moulding number

If this condition is detected or brought to your attention by an owner, on vehicles sold during the last 12 months, then the coil to ignition lead must be changed for the modified type, which has a moulding number stamped on the right angled coil boot. The earlier type has no moulding number.
