SERVICE INFORMATION

LAND - ROVER

Vol. 2 Issue 3

June 1974

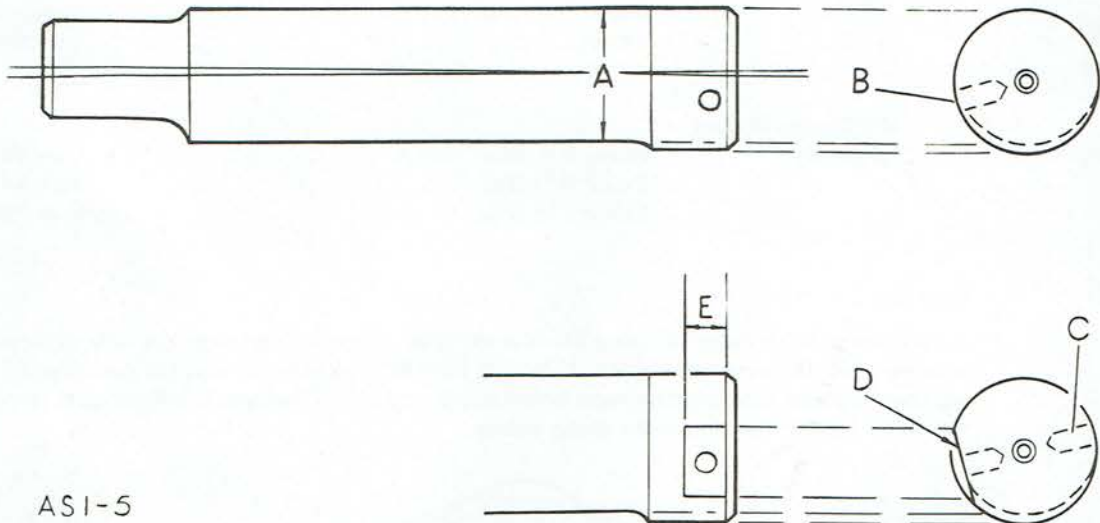
Subject: Reverse gear 'jump-out'

The outside diameter of the gearbox idler shaft (A) is deliberately machined at an offset angle to assist reverse gear retention under arduous operating conditions. It is correctly located in the gearbox by a cross-drilled hole (B) which is engaged by a spring dowel, part number 591519.

If reverse gear jump-out is experienced with gearbox numbers prior to 90208170A, 24600273A, 95109042A, 94110746A or 26600408A, it is possible this is due to incorrect location of the offset idler shaft caused by the cross-drilling being 180° out of position, see C.

Where a correctly drilled shaft part number 591527 is not available the original shaft can be easily modified as follows:—

1. Remove the spring dowel from the incorrect hole in the idler shaft.
2. Grind a flat (D) 0.04in (1mm) deep on the shaft at 180° to the existing incorrect hole, to remove the case hardening.

NOTE: The flat area (E) must not extend completely across the length of the concentric finished diameter.

3. Drill a hole 0.157in (4mm) dia., 0.210in-0.230in (5.3-5.8mm) deep, 0.200 ± 0.01 in (5.08 ± 0.25 mm) from the end of the shaft and at 180° to the existing hole.
4. Re-assemble using the new cross-drilling for the spring location dowel.

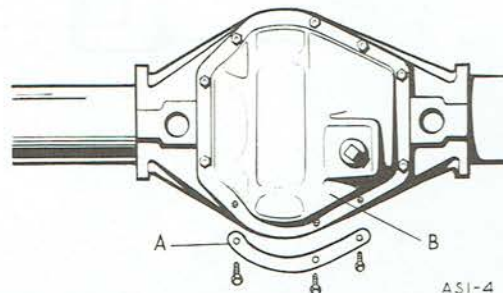
Subject: Rear Salisbury axle-flitch plate.

An additional flitch (support) plate (A) is now fitted in conjunction with the fully stiffened swaged housing cover (B) introduced in Vol. 1, No. 23, Item 96. This is to increase the protection of the housing cover against accidental damage which could result in oil leakage. The flitch plate is mounted on the three bottom housing cover fixing points.
