# SERVICE INFORMATION

## LAND-ROVER

### Vol.2 Issue 7

November, 1974

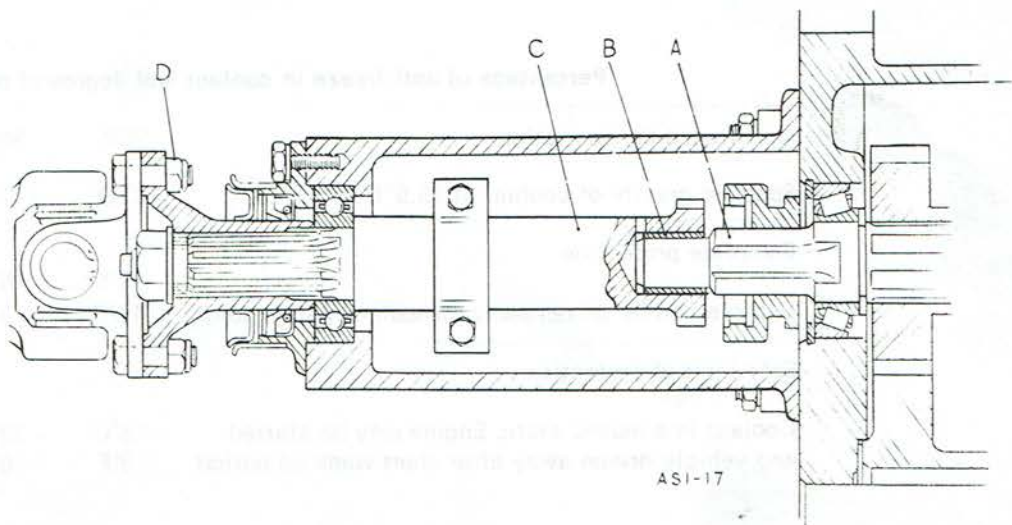
A condition may arise when **prolonged** roller testing a Land-Rover in rear wheel drive (i.e. with the front wheels at rest) where the rear output shaft (A) revolving within the stationary front output shaft bush (B) could seize, causing the vehicle to move forward.

To prevent this condition occurring disconnect the front propellor shaft (C) from the transfer shaft flange (D) and engage four wheel drive before roller testing on rear wheels is started. Both front and rear output shafts will then revolve together while the front wheels remain stationary.
