LAND-ROVER

ITEM 17

Subject: Vehicle body height variation

Vol. 2 Issue 8

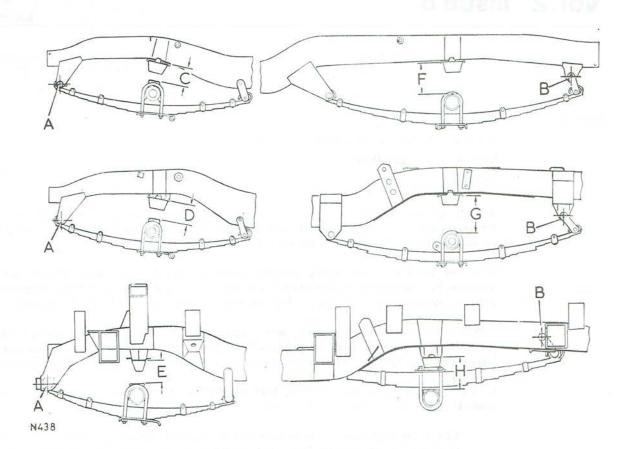
Fig. 2. Presetting position of road springs to chassis frame

With the vehicle in the static unladen condition standing on level ground measure the distance from the ground to the shackle pin centres, marked (A) and (B) Fig.2. The permissible variation between vehicle sides in front or rear suspension height is 1 in. (25 mm).

Problems have arisen occasionally with 'settling' of front or rear road springs; invariably the springs in question have been found to be within the required limits. It has been established that the apparent settling is generally a result of 'wind up' in the shackle bushes.

A-Shackle pin centre, front spring

B—Shackle pin centre, rear spring
C—3.500 in. (89 mm) 88 Bonneted Control models
D—3.750 in. (95 mm) 109 Bonneted Control models

E—4.250 in. (108 mm) Forward Control models F—5.000 in. (127 mm) 88 Bonneted Control models

G—6.000 in. (151 mm) 109 Bonneted Control models H—6.000 in. (151 mm) Forward Control models

In these cases it is recommended that the following steps be taken before considering removal of the springs for investigation.

- Remove all traces of Parkerising from the ends of the inner faces of the shackle side plates.
- 4. Replace the shackle pins, and on achieving the spring position detailed in Fig.2, tighten first the shackle pin and then the lock nut to 70 lbf. ft. (9,6 mf.kg).
- 5. Allow the vehicle weight to be taken on the road springs.
