Rover Service News Letter No. 103

May 1959

TO ALL DISTRIBUTORS AND DEALERS

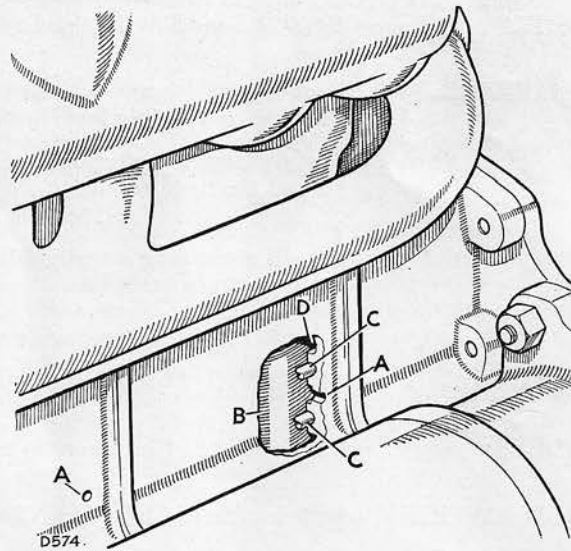
Fig. 1. Water holes in cylinder block.

REMARKS: Distributors and Dealers are requested to bring to the attention of all Land-Rover Diesel owners the need for periodical checking of the water level in the radiator, as we have recently had one or two cases of cracked cylinder heads as a result of poor maintenance in this respect.

Any unusual loss of water must be investigated immediately and the source of leakage rectified. Particular attention should be paid to the small water holes in the left-hand side of cylinder block; water at these points will indicate a leak past the top sealing ring of the cylinder liner.

A—Water hole. C—Sealing rings.
 B—Cut-away view of cylinder block showing sealing rings. D—Water jacket.

All four holes, one for each cylinder, should also be checked occasionally to ensure that they are not blocked up.

It is also important when fitting replacement cylinder liners that the grooves at the bottom of the cylinder block bores are thoroughly cleaned before the sealing rings are inserted.

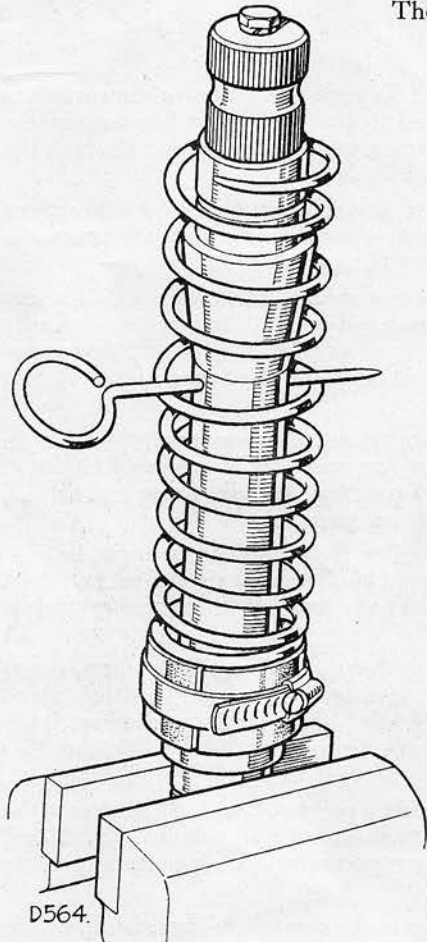
Fig. 2.

An improved and safer method of fitting the spring to the steering relay unit is now available; this is a hardened steel pin in place of the clips previously used. The pin should be used as detailed below:—

Compressing steering relay spring.

To assemble relay unit.

1. Examine all parts and renew as necessary.
2. Fit the top end plate and joint washer to the housing.
3. Fit one split bush to the taper on the bottom end of the shaft, and secure tightly with a suitable 2 in. hose clip (Part No. 50323).

4. Place a steel washer on to the shaft, next to the inner side of the Tufnol bush.
5. Place the spring over the shaft and insert the special tool (Part No. 510309) through the coils of the spring and right through the lubrication cross-drilling in the shaft.

6. The spring can now be wound down the tool until the steel washer and the split Tufnol bush can be secured to the taper on the other end of the shaft with a hose clip.

7. Remove the special tool (Part No. 510309).
8. Place a brass thrust washer on the top end of the shaft, lubricate the shaft and insert into the housing.

9. With a plastic hammer gently tap the shaft into the housing until the first hose clip slides off the Tufnol bush, remove the clip completely from the shaft.

10. Continue to tap the shaft into the housing until the second clip is freed and the shaft abuts the top end cover.
11. Fit the bleed and filler plugs, fill the unit with oil, replace the bottom end thrust washer, joint washer, end cover and tighten the retaining bolts.

12. Fit the upper relay lever.
13. If the unit is in order, it should require a force of at least 12 lb. (5,5 kg.) to turn the relay shaft, using a spring balance in the relay lever boss.
