THE ROVER COMPANY LIMITED

LAND-ROVER SERVICE NEWS LETTER
No. 16

November 1961

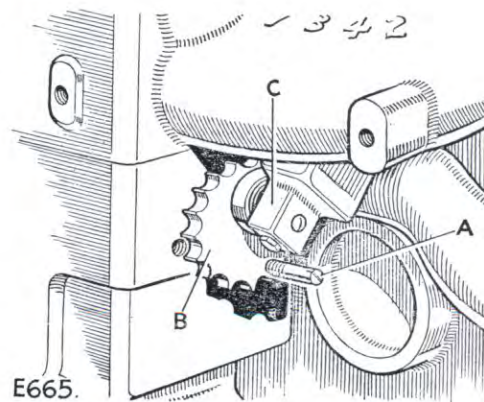
Fig. 1. Hot spot adjustment.

- REMARKS: Some complaints have been received of difficulty in starting the Land-Rover 2 $\frac{1}{4}$ litre Petrol engine when it is hot. On investigation it was found that in most cases this was due to the incorrect setting of the thermostatically controlled hot spot on the exhaust manifold. If the bi-metal spring is adjusted so tightly that it prevents the flap from closing completely when the engine is hot, the extra heat being fed to the inlet manifold, causes percolation of the fuel in the carburetter, so causing flooding. This causes difficult hot starting as well as allowing the fuel that drips from the pump injector to lie on the throttle blade and eventually leak from the throttle spindle. The thermostatically controlled hot spot should be adjusted as follows:—

1. Remove the retaining set screw A and turn the serrated adjustment plate B in an anti-clockwise direction until the balance weight C is just supported.

2. Replace the retaining set screw, selecting the appropriate serration, then tighten.
