**THE ROVER COMPANY LIMITED**

## LAND-ROVER SERVICE NEWS LETTER No. 41

February, 1964

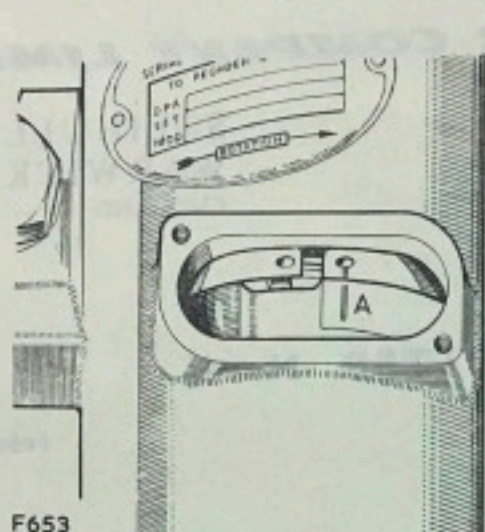
Fig. 1

**MODIFICATION:** The timing circlip on the distributor pump has been altered from a round eye to a straight edge on one side. See illustrations below.

Injection pump timing marks correctly aligned—early type

1. Align the appropriate timing mark on the flywheel with the pointer as detailed in the Land-Rover Workshop Manual.
2. Remove the inspection cover from the injection pump and rotate the spindle until the line marked 'A' on the driving plate is aligned as follows:
  - (a) Early models: Mark on timing circlip.
  - (b) Late models: Straight edge of timing circlip.
3. Offer the pump to the engine and engage in the splined shaft. With a small mirror, observe the setting through inspection aperture in injection pump and make any final necessary adjustment by turning the pump body to align the timing circlip as detailed above.

Hold the pump drive plate and press the skew drive gear back against the driving side of the teeth whilst final adjustments are made and the pump secured, in order to avoid any timing errors.
4. Recheck the timing by turning the crankshaft in the direction of rotation until both valves of number one cylinder are closed and the piston is ascending the bore on the compression stroke, continue to turn the crankshaft slowly. With a small mirror observe that the timing mark 'A' on the pump drive plate aligns as follows:—
  - (a) Early models: Mark on timing circlip.
  - (b) Late models: Straight edge of timing circlip.

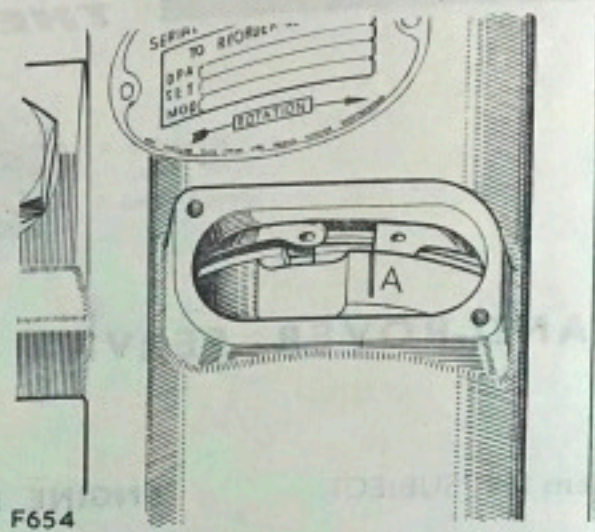
Fig. 2

Injection pump timing marks correctly aligned—late type
