THE ROVER COMPANY LIMITED

LAND-ROVER SERVICE NEWS LETTER Vol. 2 No. 22

July 1967

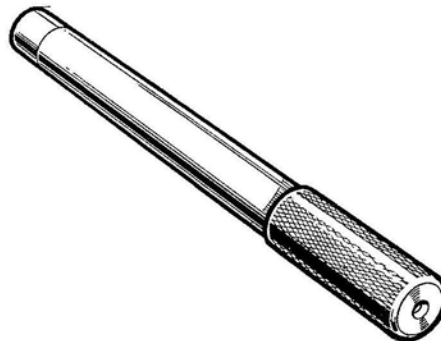
Fig. 1 Alignment tool for clutch centre plate

REMARKS: The above tool has been introduced to facilitate the alignment of the clutch centre plate. Its short overall length makes it possible to renew the clutch centre plate without the need to fully remove the gearbox from the vehicle. Supplies of this tool are available from our Parts Department.

PART NUMBER: Alignment tool for clutch centre plate 1 605022
