THE ROVER COMPANY LIMITED

LAND-ROVER SERVICE NEWS LETTER Vol. 2 No. 34

Item 172 SUBJECT:

CYLINDER HEAD (Policy Item)

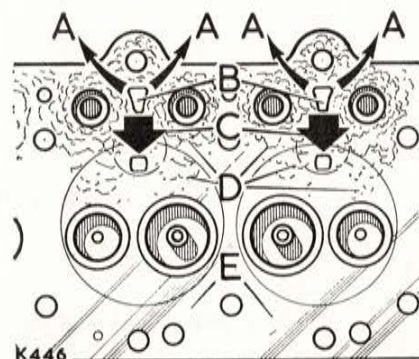
As a result of this uneven tightening, the very high operating pressures of the Diesel engine cause 'panting' of the cylinder head.

Thus, the essential seal between combustion chambers and water passages and adjoining cylinders is broken, permitting:

- (a) Pressurisation of crankcase and subsequent oil discharge through the breather, and
- (b) Water loss to combustion under induction, and to atmosphere under exhaust.

Fig. 1 below illustrates a typical cylinder head which shows unmistakably the symptoms of incorrectly tightened cylinder head bolts.

Fig. 1. Joint face of incorrectly tightened cylinder head

A—Water loss to atmosphere	C—Water loss to combustion
B—Water passages	D—Rust deposit
E—Cylinder head joint face

The heavy rust deposit in the area of the water passages has been caused by the coolant escaping for the reasons outlined under (b) on the previous page.

We are repeating below the correct procedure for tightening cylinder head bolts.

1. Ensure engine temperature is really hot.
2. Remove top rocker cover.
3. Disconnect feed pipe to each injector and slacken pipe at distributor pump end. Then swing pipes clear of injectors.
4. Disconnect spill pipe at 'T' piece and slacken banjo bolts on nozzles.
5. **Early models.** Remove the nuts retaining the clamp bar on the top of the injector and remove the bar.
Late models. Remove flange securing nuts.
6. Check cylinder head bolt tightness in the order indicated at Fig. 2, ensuring that all the $\frac{1}{2}$ in. nuts and bolts are pulled down to 90 lb. ft (12,5 mkg).

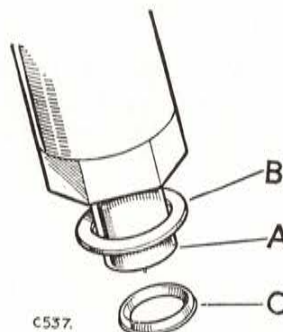
Fig. 3. Position of injector nozzle washers

A—Nozzle B—Copper washer C—Steel washer

7. Check injectors as required.
8. Smear new copper joint washers with grease and fit one to each injector. Insert a new corrugated sealing washer into each injector nozzle recess in cylinder head, with raised portion upwards, then fit injector nozzles.
9. **Early models.** Replace clamp bar and nuts.
Late models. Refit flange securing nuts.
Do not tighten nuts fully at this stage.
