Land-Rover Service Newsletter Vol. 3 No. 13

June 1970

The Rover Company Limited Service Department: Solihull, Warwickshire, England

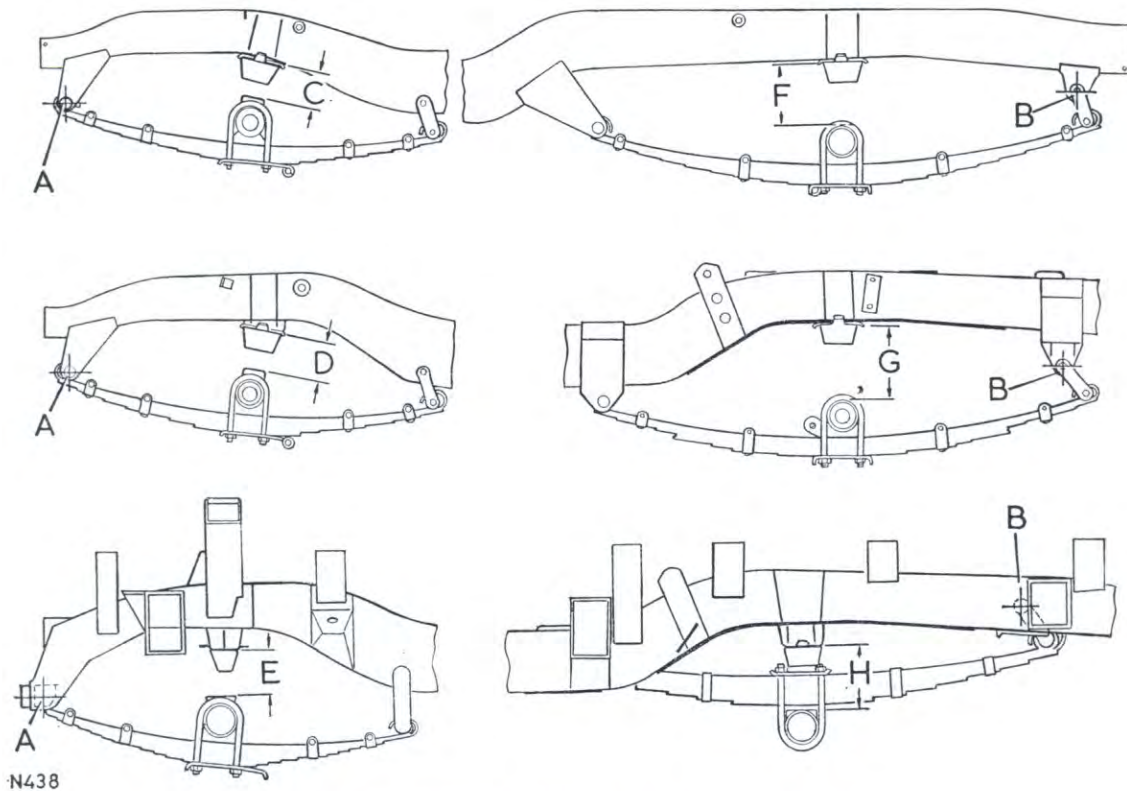
Fig. 2. Presetting position of road springs to chassis frame

REMARKS: With the vehicle in the static unladen condition standing on level ground, measure the distance from the ground to the shackle pin centres marked 'A' and 'B' at Fig. 2. The permissible variation between vehicle sides in front or rear suspension height is 1 in. (25 mm).
Problems have arisen occasionally concerning the 'settling' of front or rear road springs. Invariably the springs in question have been found, on examination, to be within the required limits.
Our investigations into this matter have established that the apparent settling is generally a result of 'wind up' in the shackle bushes.
In all cases of 'spring settling' it is therefore recommended that the following steps be taken before considering removal of the springs for investigation.

2. With the vehicle weight taken off the road springs, remove the shackle pins. If they are not a free fit in their mating threads or in the rubber bush inner sleeves, this condition should be achieved by the use of emery cloth and oiling the threads, or if necessary, by reaming the holes through which the shackle pin passes.
3. All traces of Parkerising should be removed from the ends of the inner faces of the shackle side plates.
4. Replace the shackle pins, and on achieving the spring position detailed in Fig. 2, tighten first the shackle pin and then the lock nut to 70 lbs ft (9,6 mkg).
5. Allow the vehicle weight to be taken on the road springs.
