Land-Rover Service Newsletter Vol. 3 No. 15

August 1970

The Rover Company Limited Service Department: Solihull, Warwickshire, England

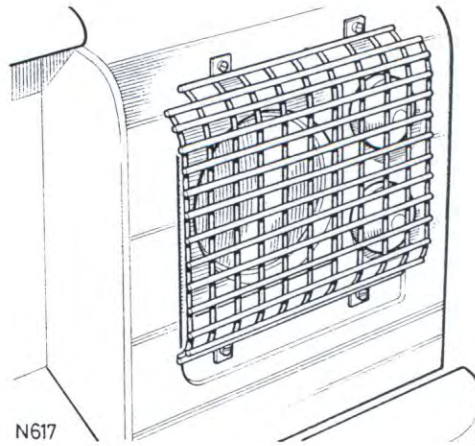
Fig. 1. Wire mesh guard, front illustrated

MODIFICATION: Introduction of wire mesh guard for the protection of side, stop and flasher lamps.

It should be noted that the rear wire mesh guards are not affected and are the same as specified for vehicles prior to chassis suffix letter 'G'.
