Land-Rover Service Newsletter Vol.3 No.20

January 1971

The Rover Company Limited Service Department, Solihull, Warwickshire, England

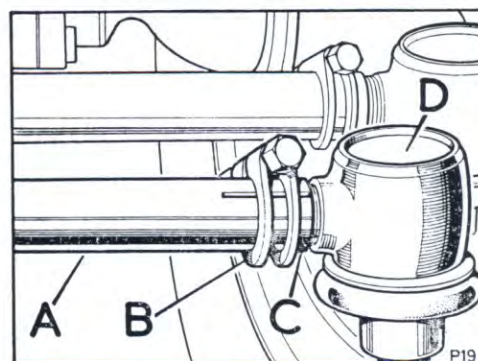
Item 128 SUBJECT: **STEERING ROD CLIPS AND BALL JOINTS**
 MODELS: Land-Rover, all models.
 REMARKS: Further to the information circulated by means of Land-Rover News Letter Vol. 3 No. 18, item 214, it is important that the steering ball joints are thoroughly inspected at the recommended 6.000 km (4,000 miles) intervals.
 Ensure that there is no undue wear, and that the rubber boot is not dislodged or damaged.
 The check should be extended to ascertain the effectiveness of the steering rod clips, especially when vehicles are operating under extremely arduous conditions. Early type clips, Part No. 552038, which show evidence of distortion, should be replaced by the modified type, Part No. 577898.
 The correct position of the clip is shown at Fig. 1.
 The relevant tightening torques are as follows:
 Ball joint fixing nut: 4 mkg (30 lb ft).
 Clamp retaining nut: 1,4 mkg (10 lb ft).

Fig. 1 Correct position of steering rod clip

It should be noted that the highest clamping effect, in particular on linkages with one slot only, is achieved with the open section of the clip situated over the slot.
