Land-Rover Service Newsletter Vol. 3 No. 25

July 1971

The Rover Company Limited Service Department: Solihull, Warwickshire, England

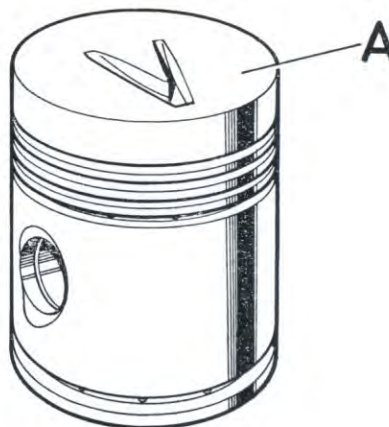
IRC 597

Item 147 SUBJECT: PISTON SEIZURE

REMARKS: To minimise piston seizure, there has been a modification to increase the tolerance of the piston to cylinder bore clearance by 0,010 mm (.0004 in.) but there has been no alteration in part number.

Distributors and Dealers involved in investigating cases of piston seizure should check the date-stampings on the piston crowns before taking any action.

Fig. 1 Piston identification
A—Piston crown date stamped

If the date of manufacture was later than April 1970, then Product Investigation Section of Technical Service Department should be advised immediately.

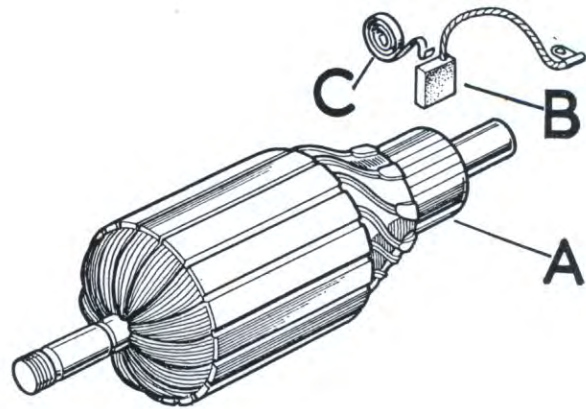
IRC 600

- Item 150** SUBJECT: **DYNAMO NOISE**
- MODELS: All Land-Rovers.
- REMARKS: Complaints of dynamo noise have been investigated and in the majority of cases the noise has been found to emanate from the commutator.
- It can be cured by the application of a small quantity (about the size of a match head) of M.S.4 silicone grease to the commutator.
- This treatment does not affect the life or correct operation of the dynamo brushes.

Fig. 3 Dynamo armature. 2½ litre petrol illustrated
 A—Commutator B—Brush C—Brush spring

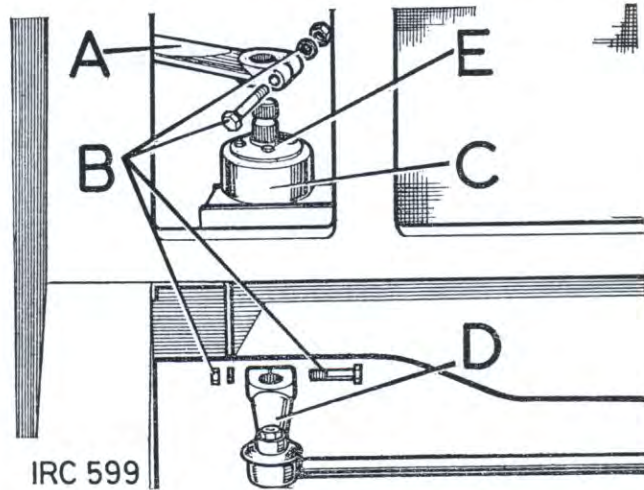
IRC 599

As a result of complaints of oil leakage from steering relay, Part No. 562874, investigations have been carried out which show that seals, Part No. 213340 have been damaged in a way which suggests the use of a lever or wedge to remove the relay levers.

Fig. 4 Relay levers

Operation G1-9 in Land-Rover Workshop Manual, Part 2, Part No. 606408 instructs that the levers should be prised clear of the relay unit after the fixings have been removed, but the operation must be carried out carefully to avoid damage to the seals, Part No. 213340 and resultant leakage.
