Land Rover

LT66 4 CYL

TRANSMISSION

Transfer Box — 4 cyl

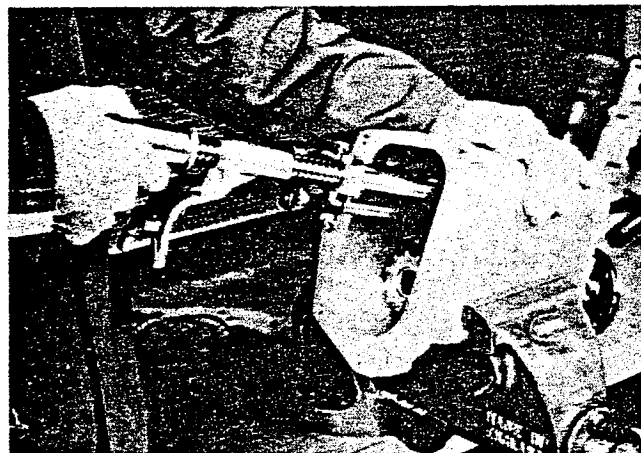
Fig. 39

Assemble the four-wheel drive high/low selector as shown in (Fig. 35) and partially install it in the housing as shown in (Fig. 39). Fit the four-wheel drive selector dog.

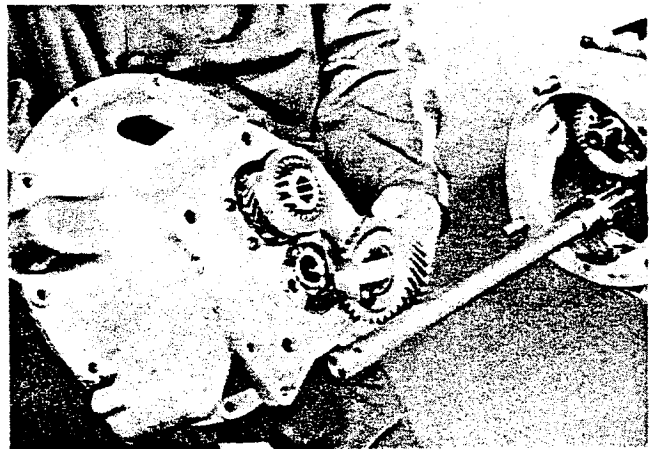
The metal bar shown in Fig. 52 is screwed into the end of the layshaft.

Note that the primary gear, conical distance piece and spigot roller bearing will be detached by removal of the housing and should be restrained from falling.

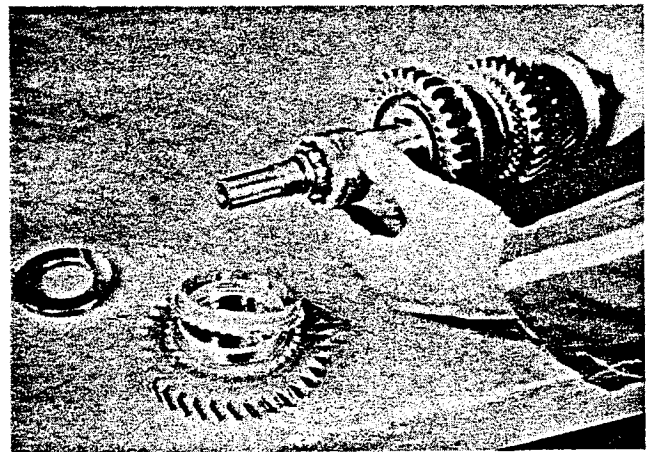
Fig. 58

Slide off the loose gears and washers from the rear of the shaft, taking care that the inner and outer members of the synchronesh unit do not separate (Fig. 58).

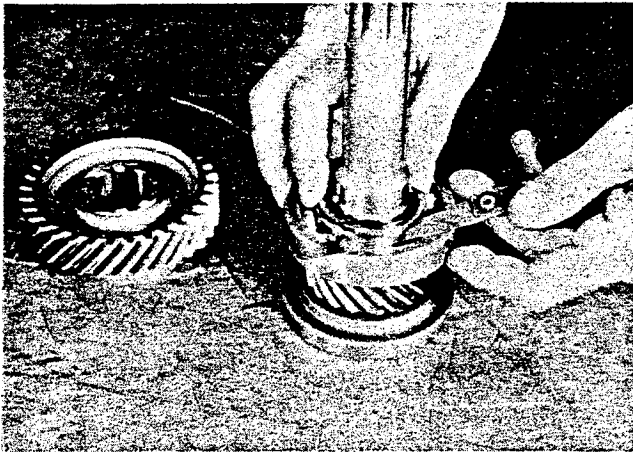
Fig. 79

Press the new bearing onto the primary shaft and fit the distance washer and circlip. When the circlip is in position, the washer selected must be free to rotate with minimum end play (Fig. 79). Four thicknesses of washer are available.
